Mahaweli Water Security Investment Program

Semi Annual Environmental Monitoring Report (SAEMR) No. 08 (July to December 2020) for Upper Elaheera Canal Project (UECP)

Ministry of Irrigation
Sri Lanka

January 2021
Final Report

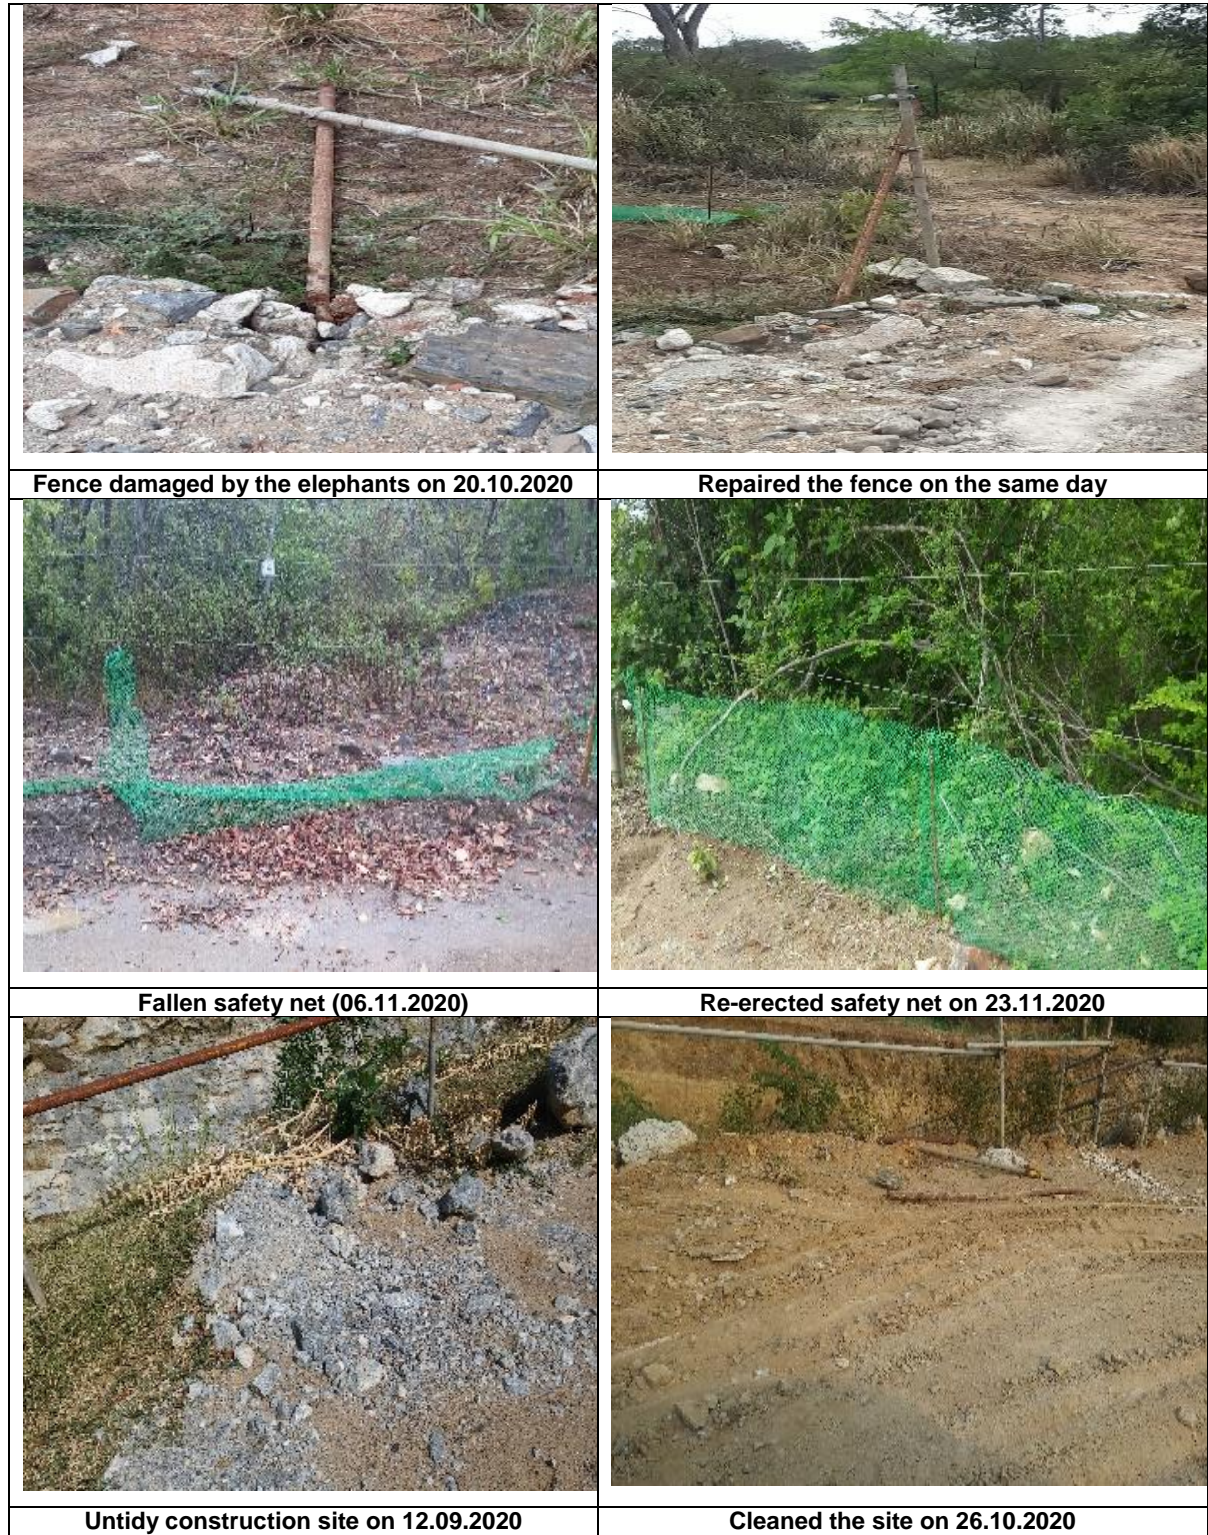
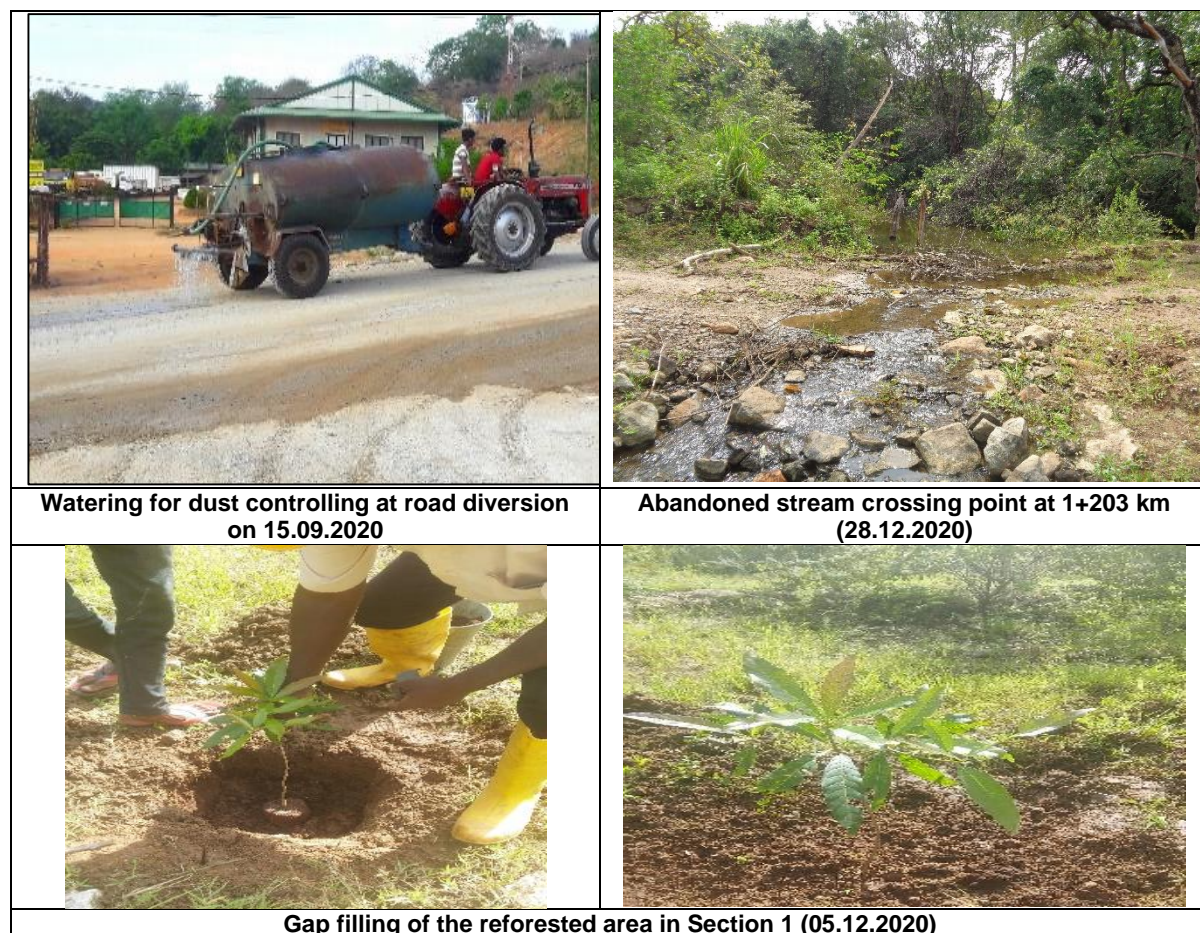
Figure 2-1: Photographic records of Environmental Monitoring in UECP-ICB-1

19. The photographic evidence for the environmental issues and incidents recorded by PMDS in the UECP-ICB-1 area during environmental monitoring period is shown in **Figure 2-1**.

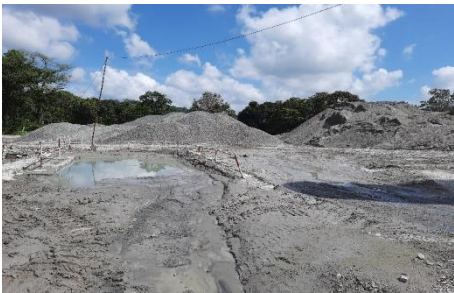
Reference	Environment Issue/concern	Photographic evidence
PMDSC-KMTC-RE/ICB-2B/ShCL/L1007 on 14 December 2020	<ul style="list-style-type: none"> (i) Absence of effective wastewater treatment facility to Lel Oya Batching plant area, and operating batching plant against EPL conditions (ii) Poor housekeeping at Lel oya batching plant premises (iii) The wastewater treatment unit has not been connected to the wastewater conveying pipe and wastewater is still

<p>Lel Oya batching plant with sludge</p>

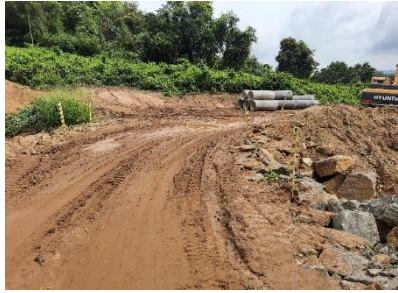
<p>Lack of stream diversion / drainage arrangements at T1 inlet</p>

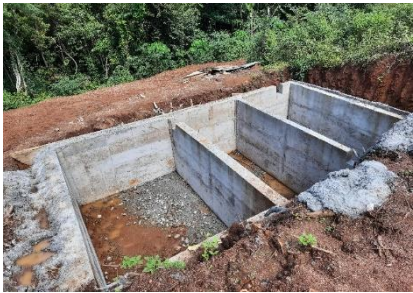
<p>Incomplete wastewater treatment unit at T1 inlet</p>
<p>PMDSC-KMTC-RE/ICB-2B/ShCL/L909 on 15 September 2020</p>	<p>(i) Dumping of the mucking materials beyond the given boundaries at Kabarawa T2 outlet area. This was immediately stopped, and action was taken to use the DS no.01 with the approval of the CEA. On the request made by RE to PMU/PIU to identify alternative lands for this disposal, PIU informed (through letter UECP/ PD/ KMTC/ 01-ii on 26/11/2020) that FD verbally said that there is no possibility of expanding the land with no addendum / supplementary EIA is done to assess possible impacts, and hence to optimize the disposal land without disturbing existing wetland/ streams of the area.</p> <p>(ii) Operating Lel oya batching plant area violating EPL conditions</p> <p>(iii) Wastewater discharged to Lel oya from tunnel 2 inlet by overflowing the sedimentation tanks. Immediate attention was taken to stop flowing sediment by putting sandbags across the stream, and cleaned the section by dewatering/ flushing</p>

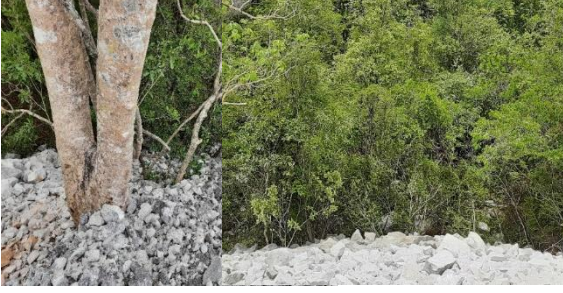
<p>Capacity exceeded Disposal site</p>

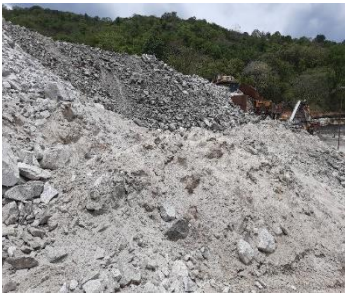
<p>Unmanaged sludge disposal</p>

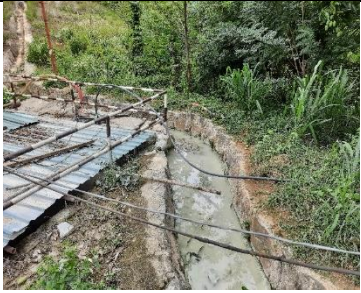
<p>Overflowed sedimentation tanks</p>

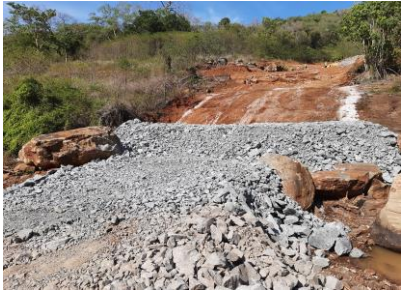
<p>Platform prepared blocking stream</p>

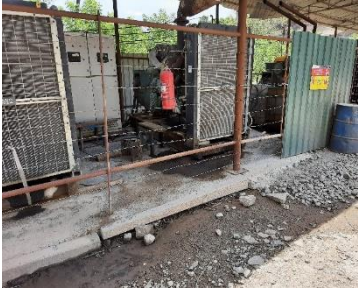
<p>Oil leak from generator</p>																																	
<p>PMDSC-KMTC-RE/ICB-2B/ShCL/L246 on 25 November 2020</p>	<p>(i) PMU /PIU was informed through the referenced letter on 25 Nov 2020, submitting additional lands for disposal of 56,000 m³ tunnel muck resulted from Tunnel 2 inlet at Lel oya. The additional land is located at Lel oya with an extent of 1.09 ha which is an abandoned paddy land</p> <p>(ii) PIU informed through Letter Ref. UECP/PD/KMTC/01-ii on 26/11/2020 that PIU will inform relevant authorities and see the possibilities to get the land, but the time taken for this process will be lengthy as it is required to carry out required environmental studies prior to approve</p> <p>(iii) PIU has informed FD seeking approval on 08 Dec 2020 though letter Ref. UEC/DPD/Env-16</p>

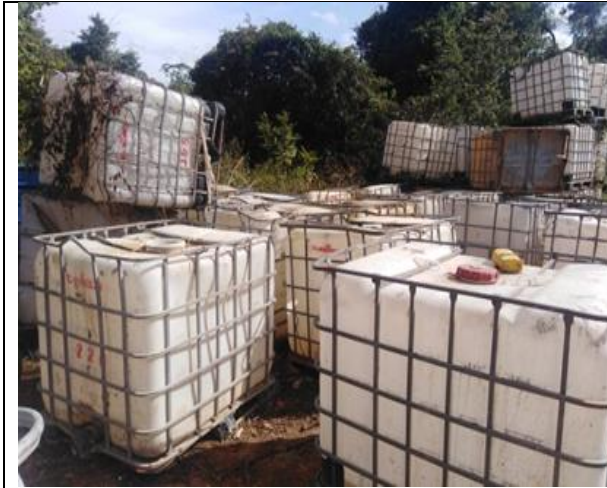
Stagnant water in the empty admixes tanks (6 Oct 2020)

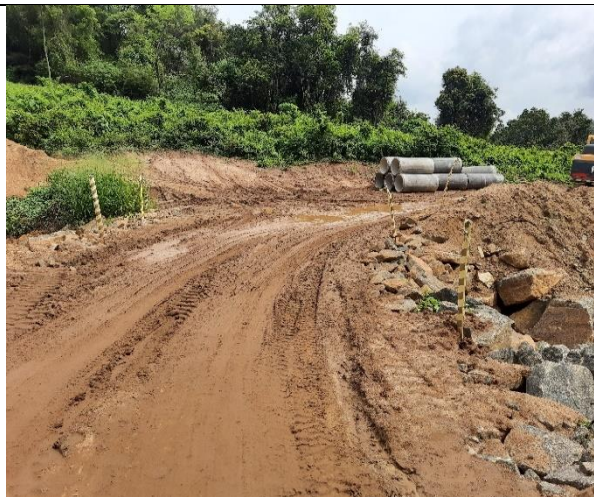
Stream blocking at access to T1 inlet portal Lel oya (22 Dec. 2020)

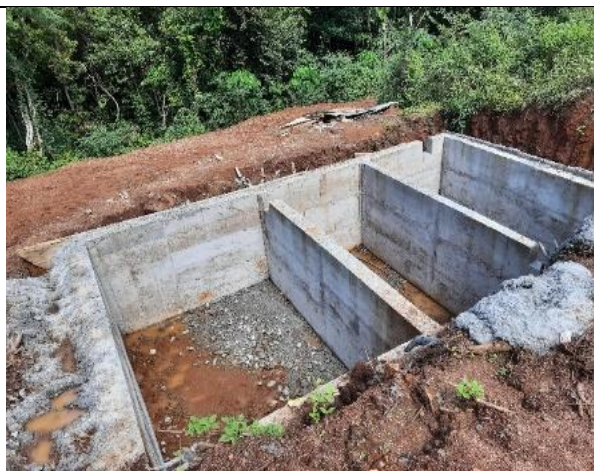
Incompleted sedimentation tanks tunnel 1 inlet (16 Dec. 2020)

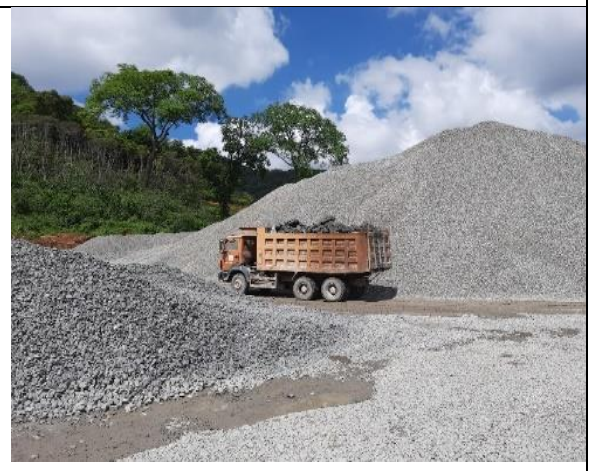
Overloaded dump trucks running in the work site absence of Tailgates (11 Dec. 2020)
