Mahaweli Water Security Investment Program

Semi Annual Environmental Monitoring Report (SAEMR) No. 09 (January to June 2021) for Upper Elaheera Canal Project (UECP)

July 2021
Report

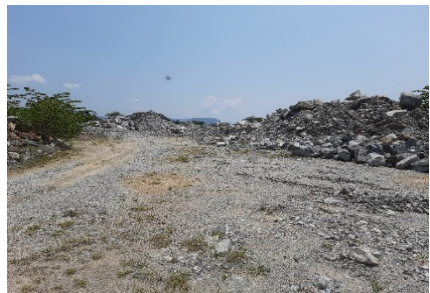
| Site Type | Site Location (chainage / GPS coordinates) | Ownership | Approximate Extent (ha) | Restoration / handing over status | Photographic evidence |
|---|--|---|---|---|---|
| Main temporary Disposal site 1 | 499588 578773 | DWC/FD | 1.46 ha, Average Height 4.5m | Not submitted any restoration plans, and not restored | |

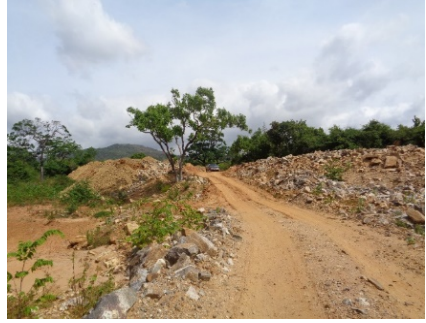
| Site Type | Site Location (chainage / GPS coordinates) | Ownership | Approximate Extent (ha) | Restoration / handing over status | Photographic evidence |
|---|--|---|---|---|---|
| Temporary Disposal site 2-End point | 499635 581218 | DWC/FD | 0.54 ha, Average Height 3.7m | | |

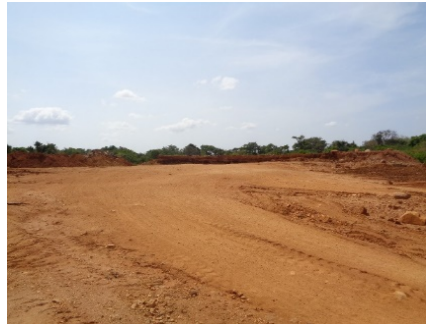
| Site Type | Site Location (chainage / GPS coordinates) | Ownership | Approximate Extent (ha) | Restoration / handing over status | Photographic evidence |
|---|--|---|---|---|---|
| Temporary Disposal site 3-End point | 499635 581205 | DWC/FD | 0.47 ha, Average Height- 2.9m | | |

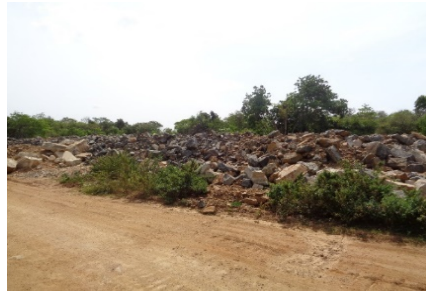
| Site Type | Site Location (chainage / GPS coordinates) | Ownership | Approximate Extent (ha) | Restoration / handing over status | Photographic evidence |
|---|--|---|---|---|---|
| Temporary Disposal site 4 along the trace | 499855 577757 | DWC/FD | 0.57 ha Height 1.8m | | |

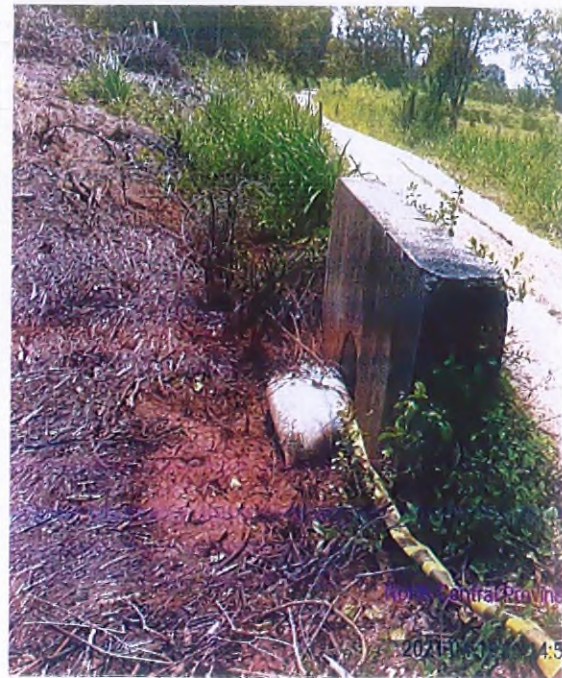
Northern Shaft area water path beside the filling area.

Culvert for the water path.

- I. Natural water way (occasional) across the site beside the land filling area for proposed segment yard.
 - a. Loose soil heap beyond the cut slope of the filling will be removed from the place.

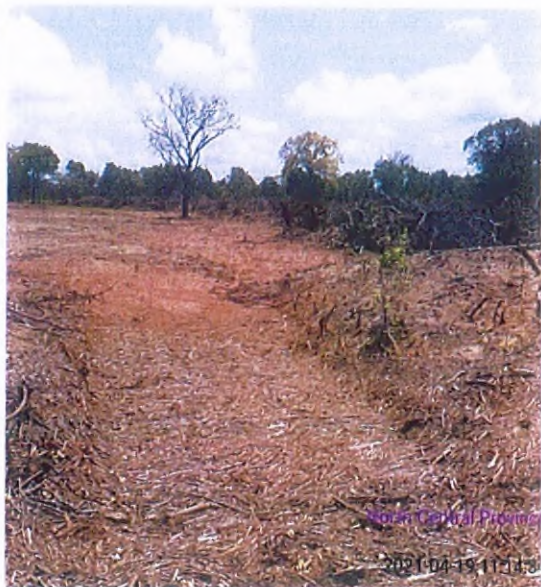
Water path.

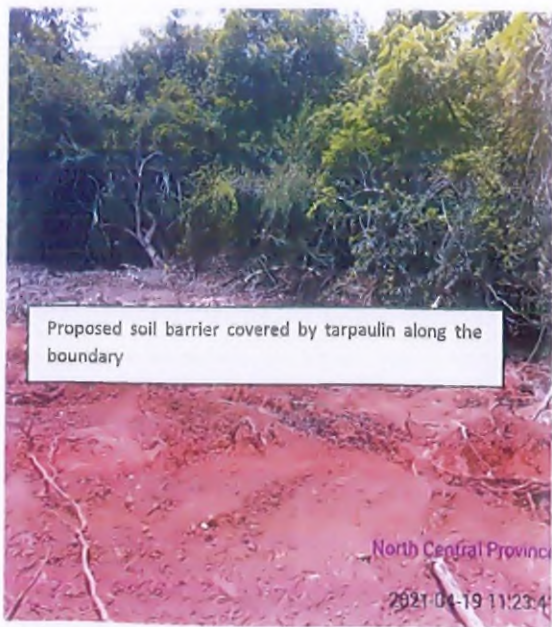
Proposed soil barrier covered by tarpaulin along the boundary

- b. Existing soil near the catchment area will be taken back by 5m and covered by temporary tarpaulin coverings.

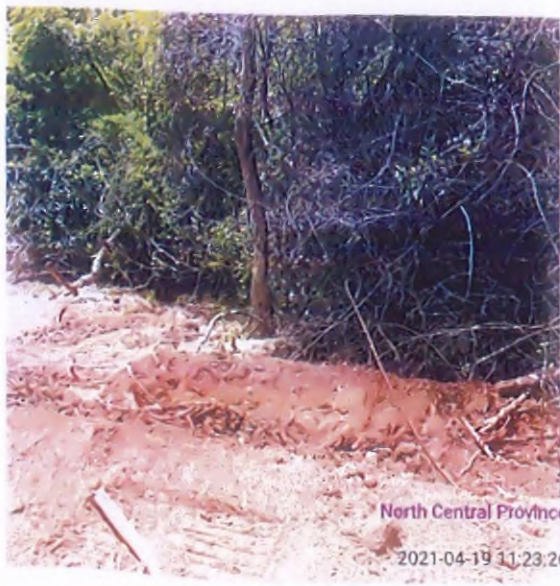
Contractor main camp southern boundary
Soil erosion area.

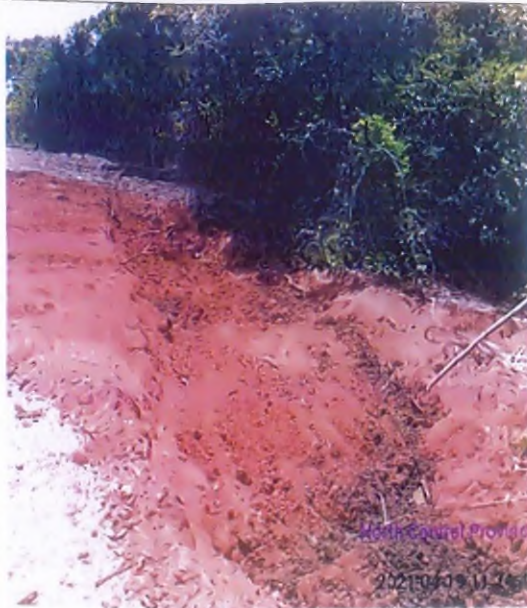
Contractor main camp southern boundary
Soil erosion area.

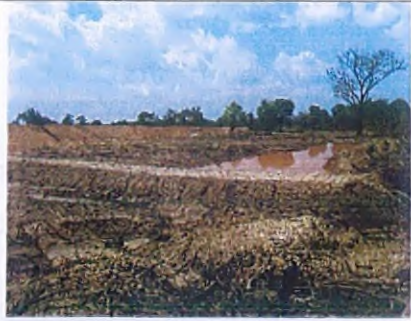
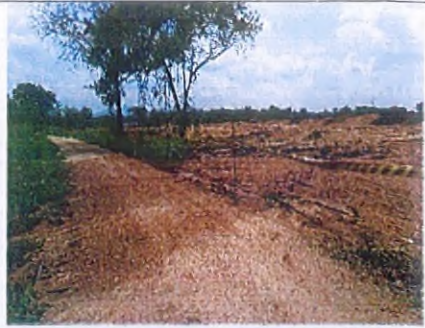
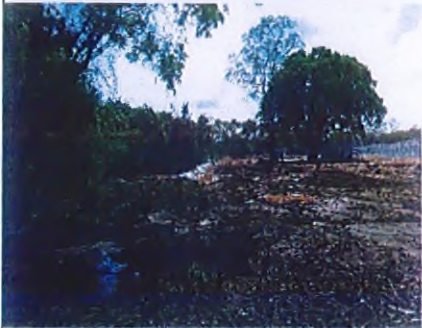
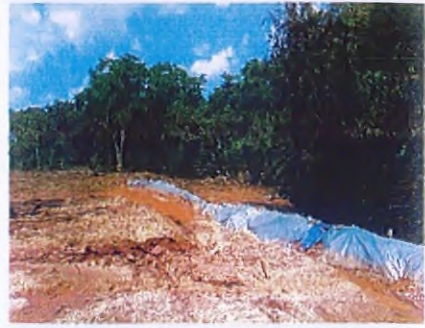
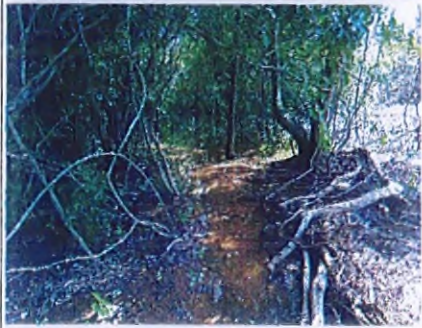
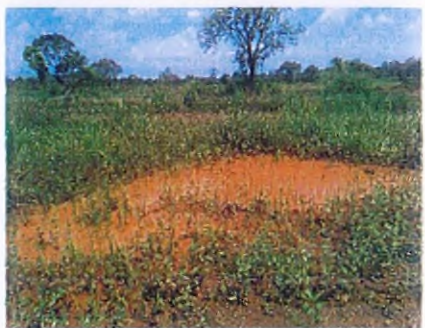
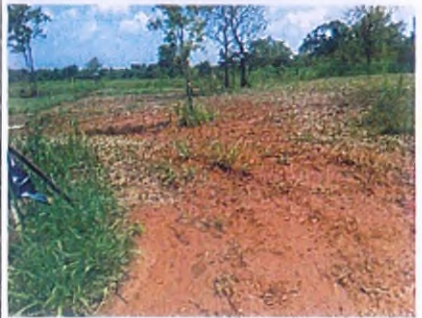
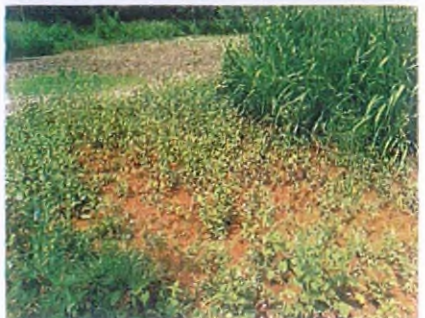
| Date | Progress |
|---|---|
| <p data-bbox="213 342 363 405">Up to 20-04-2021</p> | <p data-bbox="426 342 1315 443">The Contractor neglected to take any erosion protection measures before the site closer period from 11 April 2021 despite repeated verbal and written instructions given to him.</p> <p data-bbox="426 448 1315 719">On 19 April 2021, the Contractor started earthmoving work without having any erosion protection measures. It was observed that, due to torrential rains during site closure period, sediment washed to the tank and by the time of site opening all sediments were settled in the tank bed. The villagers of the area noted that the color of the water in whole tank changed after the rain events due to sediment flow. No major destruction was observed in paddy field area since sediment was washed away to the tank across the paddy fields due to torrential rains.</p> <p data-bbox="426 723 1315 824">A joint inspection was conducted with the participation of PIU, PMDSC, CSCEC and representatives of Farmer Organization of Maha Meegaswewa. During the Joint Inspection, the Contractor agreed to attend to the following:</p> <ol data-bbox="475 828 1289 958" style="list-style-type: none"> <li data-bbox="475 828 1289 891">1. Make temporary arrangements immediately to avoid further soil erosions of the area. <li data-bbox="475 896 1289 958">2. Take permanent actions to protect the area following submission of proposals for permanent measures for the Engineer's approval. <div data-bbox="416 972 1289 1626"> </div> |
| <p data-bbox="213 1648 347 1711">21-04-2021 onwards</p> | <p data-bbox="426 1648 1315 1816">No acceptable temporary preventive measures were implemented except for preparing an uncovered soil bund as a "silt trap" u/s of the second culvert. One covered soil bund has been prepared just above the tank, leaving a critical area open. Heavy rain during the night of 21 April 2021 caused considerable damage to paddy lands and the tank.</p> |

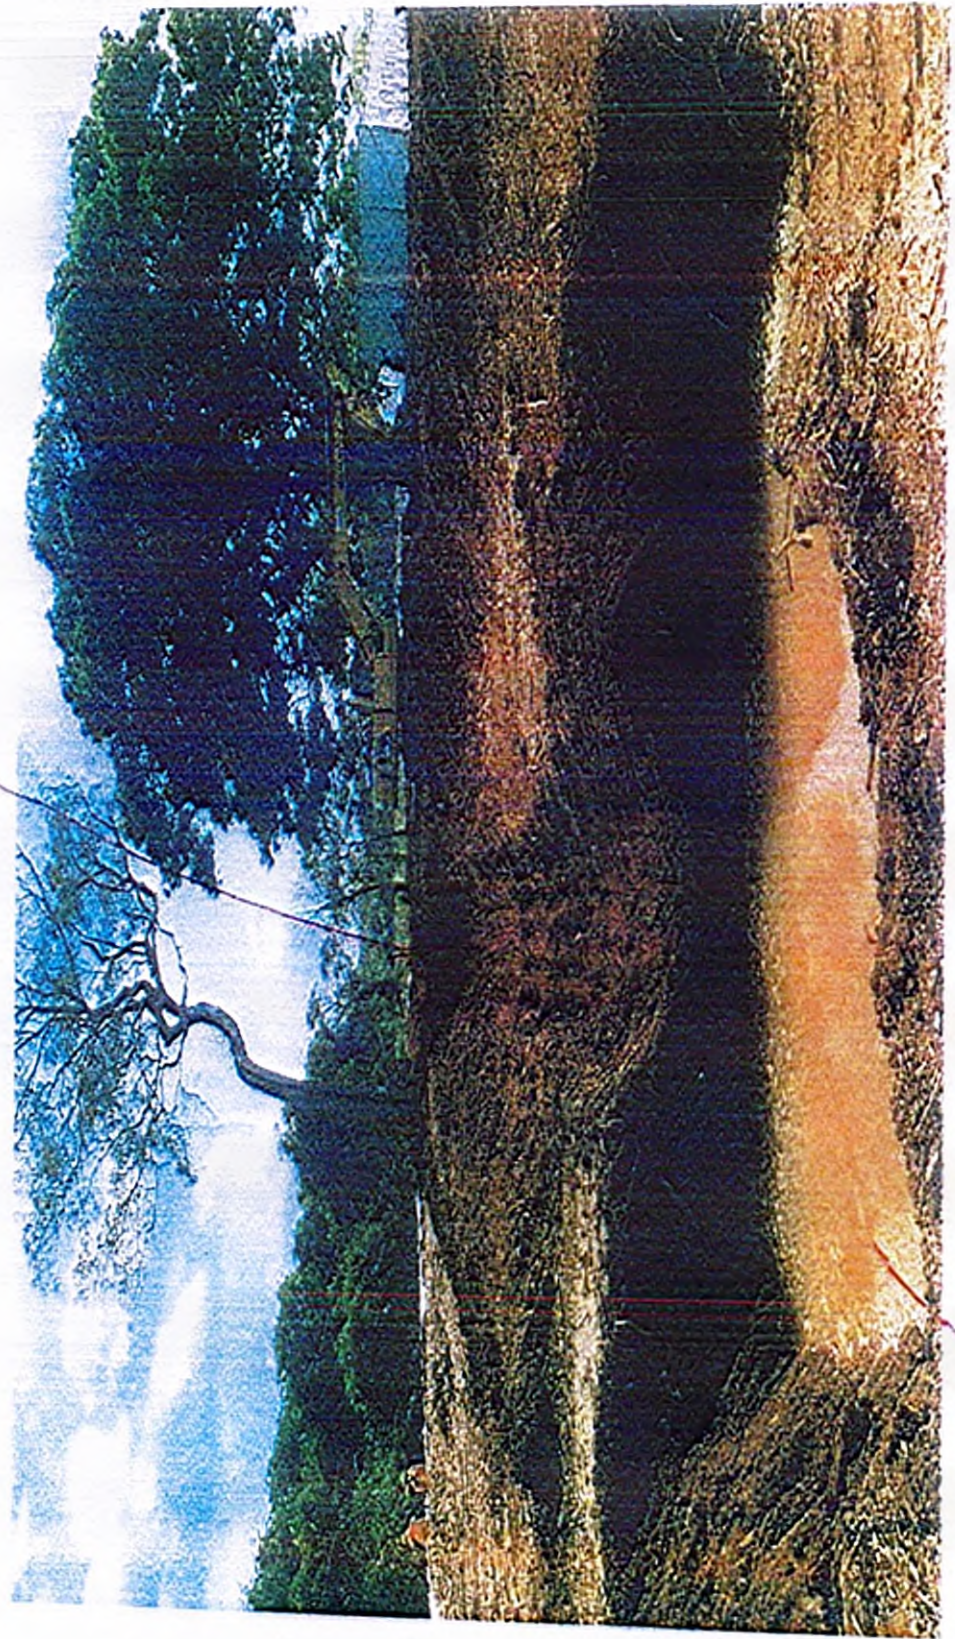
temporary water drain

Sediment tank
to collect rainwater

1. Implement temporary mitigation measures to prevent further damage by 26 APR 2021 and update the Engineer on the implemented actions with photographic evidence by 27 APR 2021;
2. Devise & implement permanent mitigation measures based on the Contractor's MS, as expected by 01 MAY 2021, reviewed & approved by the ENG;
3. Strengthening & supporting the Contractor's Environmental team with necessary resources and supports from the Contractor's management;
4. Continuous site monitoring by the CON & ENG for effectiveness and sufficiency of implemented mitigation measures;
5. Identify other potential events, which could result in environment & social grievance of the public, to evaluate jointly possible mitigation measures as well as a joint commitment.

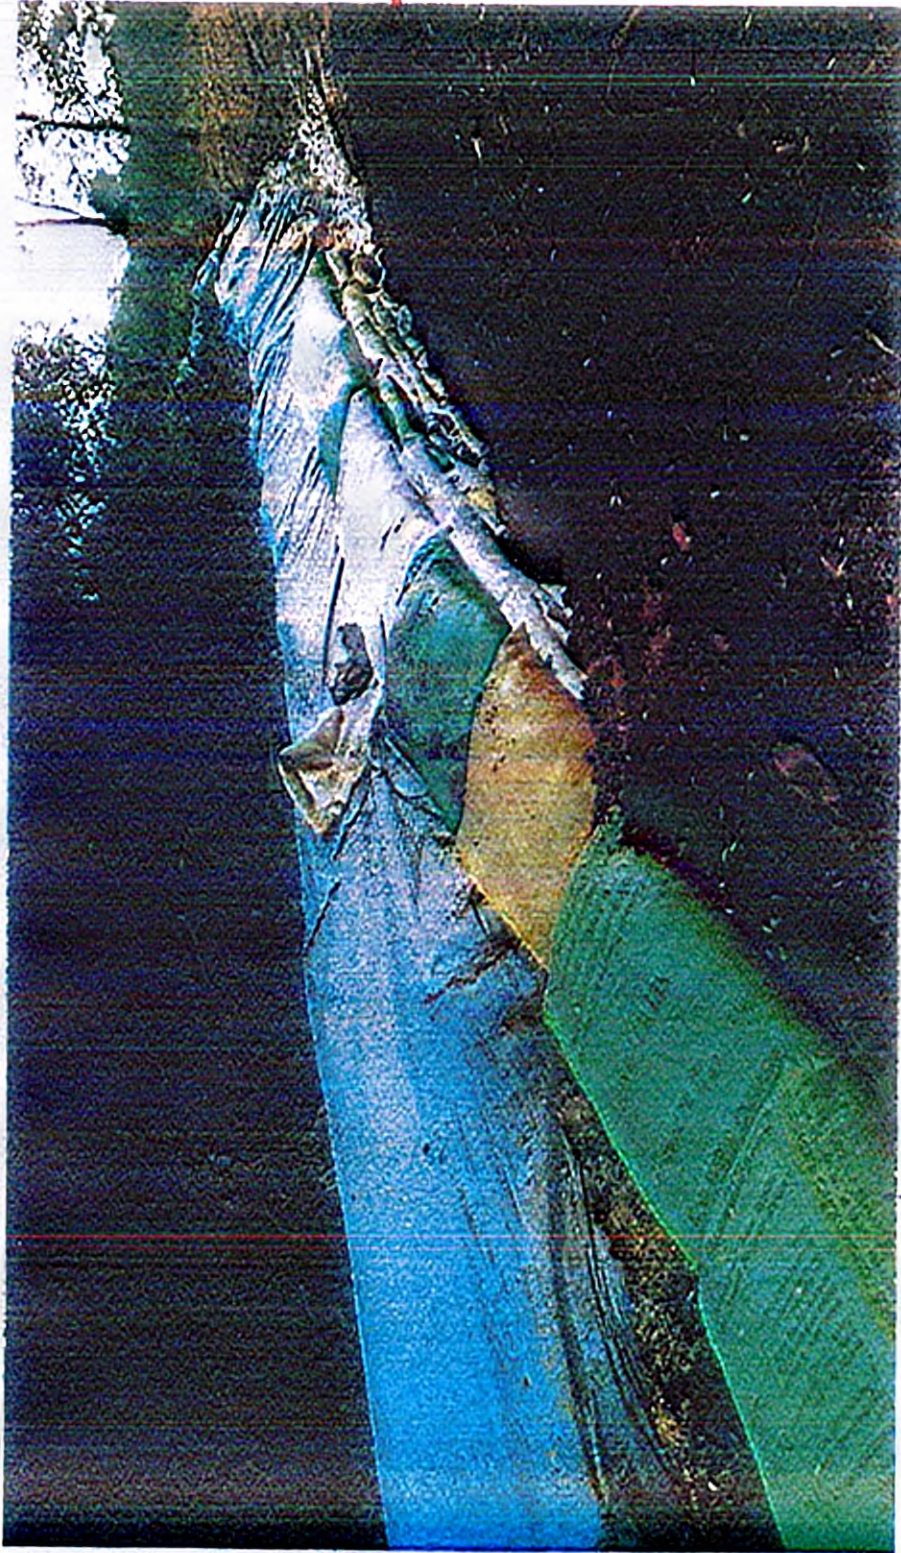
Slope
Trimm

Geotextile bags sample
(50m length)
Height: 100cm

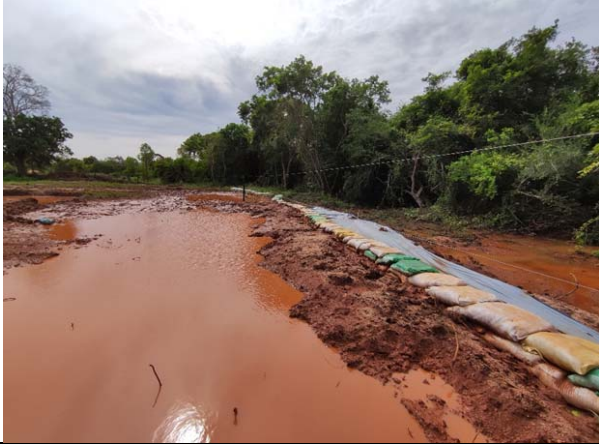
| 5MAHAWELI WATER SECURITY INVESTMENT PROGRAM (MWSIP) | |
|--|---|
| <p>An irreversible damage caused to the environment due to negligence of the Contractor and not committing to the job responsibilities of the Contractor's, in particular non-compliance with following:</p> <ol style="list-style-type: none"> (i) Soil Conservation Act No.25 of 1951 and 29 of 1953, 1956 revision and 1996 amendment (ii) Agrarian Services Act, No. 58 of 1979 and its amendments 2000, 2011 (iii) National Environmental (Ambient Water Quality) Regulations, No. 01 of 2019 (iv) Disturbance to the area within 100 meters from the high flood level contour of or within a public lake as defined in the Crown Lands Ordinance (Chapter 454) including those declared under section 71 of the said Ordinance (v) Section 1.17.4.3 and 1.17.4.4 of the Volume-2, Employer's Requirements - Section 6 & Specification, of the Contract agreement for UECP-2A (vi) National Environmental Act No: 47 of 1980 amended by Acts No 56 of 1988 and No 53 of 2000 issued through Conditional approval from CEA (Section 4 of Ref. 08/EIA/Water/04/2012 dated 31.03.2016 and renewed approvals) EIA for UECP (June 2015) and updated EMP for UECP-2A (Dec 2020) <p>Refer to photographic documentation overleaf.</p> | |

Overtopped sand bag barrier and siltation in tank

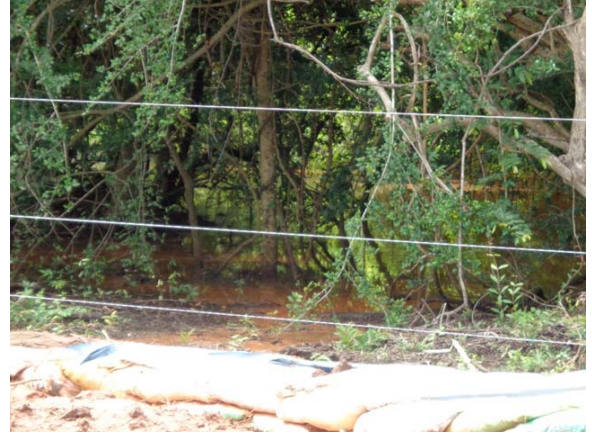
Siltation close to tank

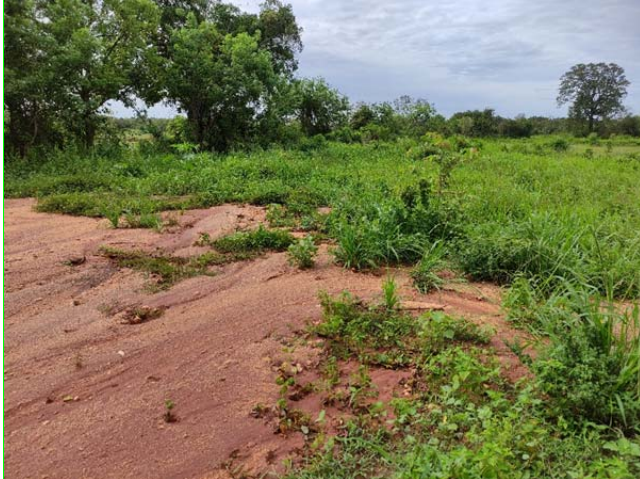
Silt flow to the paddy field area

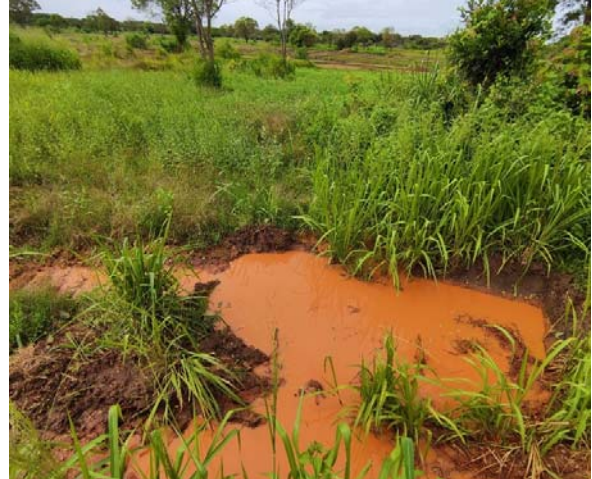
Siltation in paddy field area
