Mahaweli Water Security Investment Program

Semi Annual Environmental Monitoring Report (SAEMR) No. 08 (July to December 2020) for Upper Elaheera Canal Project (UECP)

Ministry of Irrigation
Sri Lanka

January 2021
Final Report

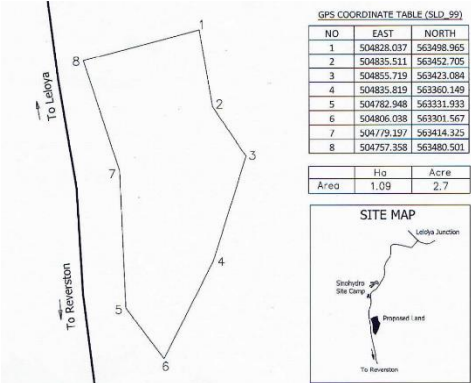
<p>Oil leak from generator</p>																																	
<p>PMDSC-KMTC-RE/ICB-2B/ShCL/L246 on 25 November 2020</p>	<p>(i) PMU /PIU was informed through the referenced letter on 25 Nov 2020, submitting additional lands for disposal of 56,000 m³ tunnel muck resulted from Tunnel 2 inlet at Lel oya. The additional land is located at Lel oya with an extent of 1.09 ha which is an abandoned paddy land</p> <p>(ii) PIU informed through Letter Ref. UECP/PD/KMTC/01-ii on 26/11/2020 that PIU will inform relevant authorities and see the possibilities to get the land, but the time taken for this process will be lengthy as it is required to carry out required environmental studies prior to approve</p> <p>(iii) PIU has informed FD seeking approval on 08 Dec 2020 though letter Ref. UEC/DPD/Env-16</p>
